# Aviation Investigation Preliminary Report

<b>Location:</b>	Kill Devil Hills, NC	<b>Accident Number:</b>	ERA24FA397
<b>Date &amp; Time:</b>	September 28, 2024, 17:18 Local	<b>Registration:</b>	N1281F
<b>Aircraft:</b>	CIRRUS DESIGN CORP SR22	<b>Injuries:</b>	5 Fatal
<b>Flight Conducted Under:</b>	Part 91: General aviation - Personal

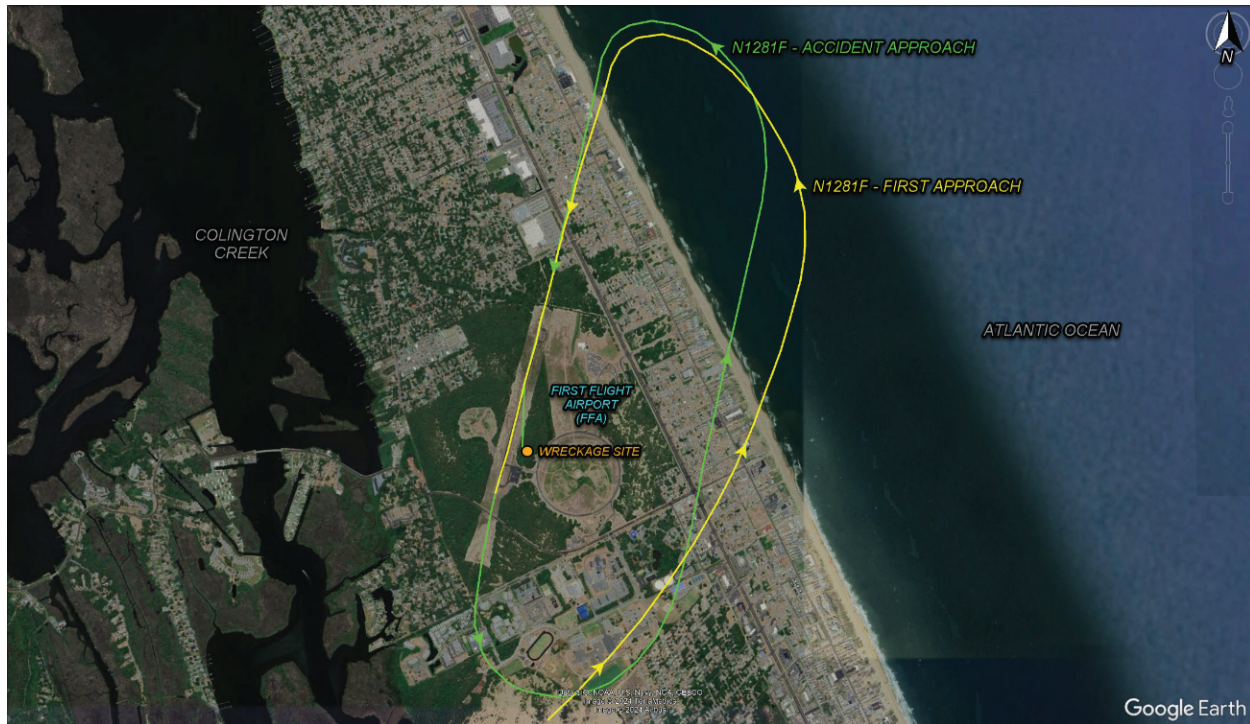
Preliminary Automatic Dependent Surveillance-Broadcast (ADS-B) data provided by the Federal Aviation Administration (FAA) showed that after departing MQI, the pilot flew to FFA and entered the left traffic pattern for runway 21. The published airport traffic pattern for runway 21 was a right-hand pattern. The pilot descended and flew above the runway. He then climbed to traffic pattern altitude and rejoined the traffic pattern using left turns. The pilot approached runway 21 a second time, and according to witnesses, was high and fast during the approach. As the airplane passed the midway point of the runway, it made a steep left turn and impacted the top of 50-foot-tall trees (see figure 1). The airplane subsequently impacted additional trees before coming to rest 300 ft east of the runway in heavily wooded terrain, where a significant postimpact fire ensued.

Figure 1- Preliminary ADS-B data showing the airplane's flight track during the accident approach (green line) and the previous approach to runway 21 (yellow line).
