# **Rodanthe Sand Needs Assessment**

Prepared for  
**Dare County, North Carolina**

# SUMMARY REPORT

May 2023

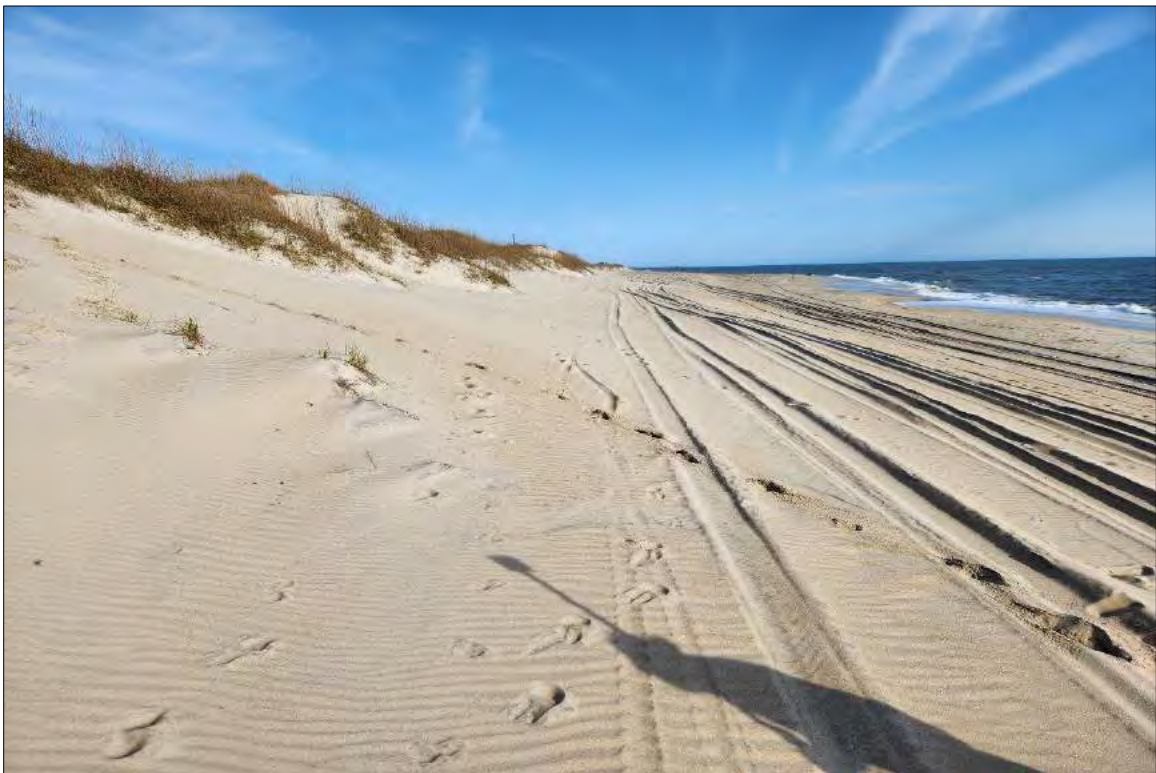
**FIGURE 1.2a.** Beach conditions along the PINWR reach vary depending on the proximity to storm-cut overwash or the former roadbed of NC highway 12 along the s-curves. Much of the reach contains a relatively wide dry sand beach and high continuous foredune crest. The ground photo location is marked in the upper photo with a red circle.

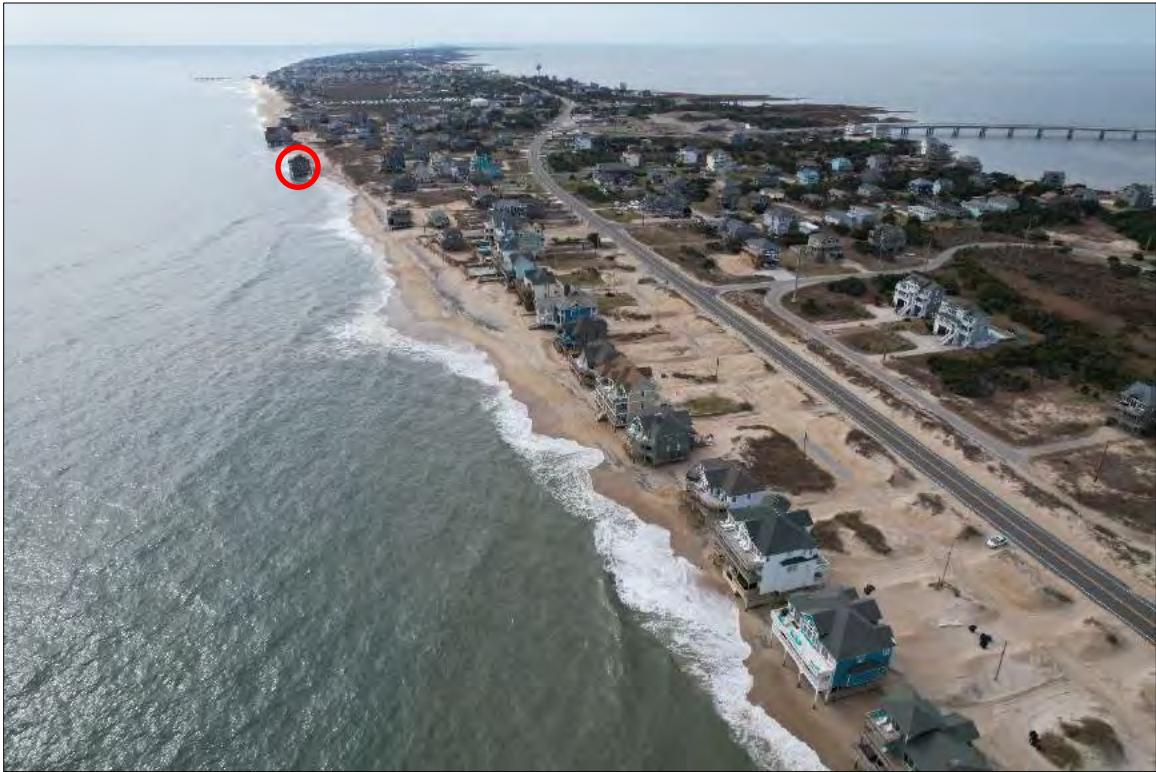
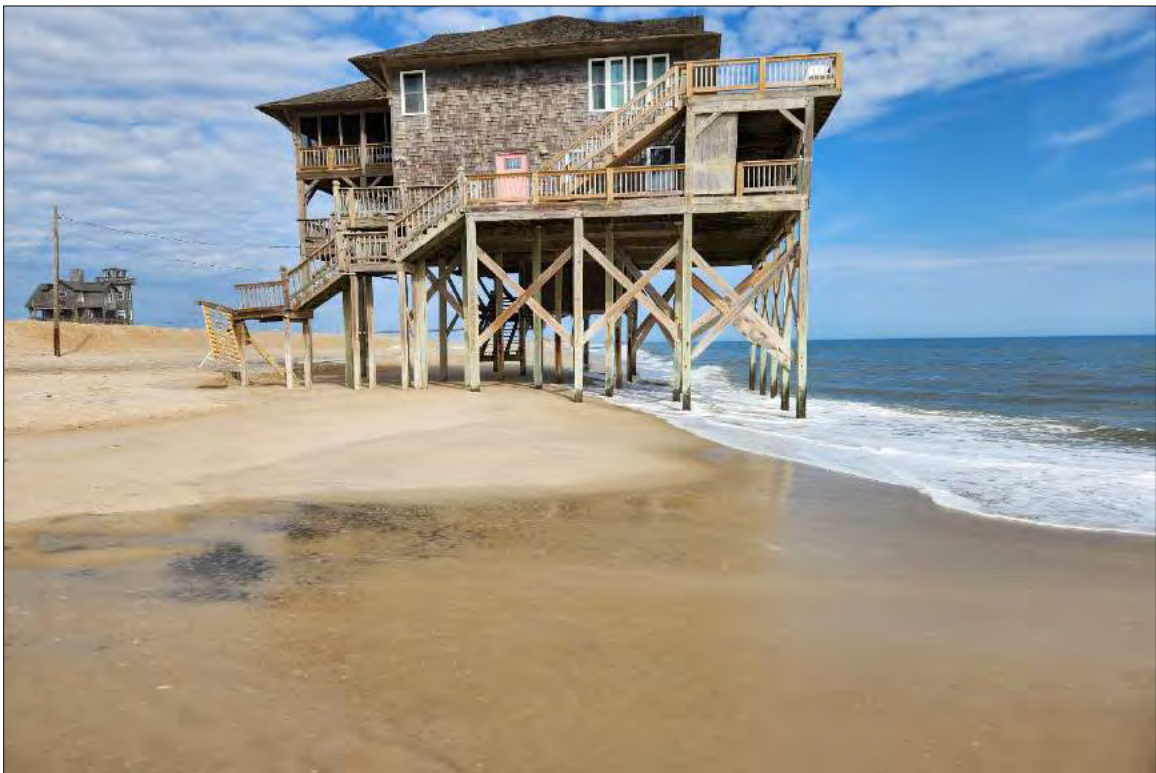
**FIGURE 1.2b.** Beach conditions along the Rodanthe reach offer little to no storm protection for many first-row homes, with several properties on the intertidal wet beach. The recent collapse of multiple such properties has compelled the County to investigate sand needs for a nourishment project at Rodanthe. The ground photo location is marked in the upper photo with a red circle.

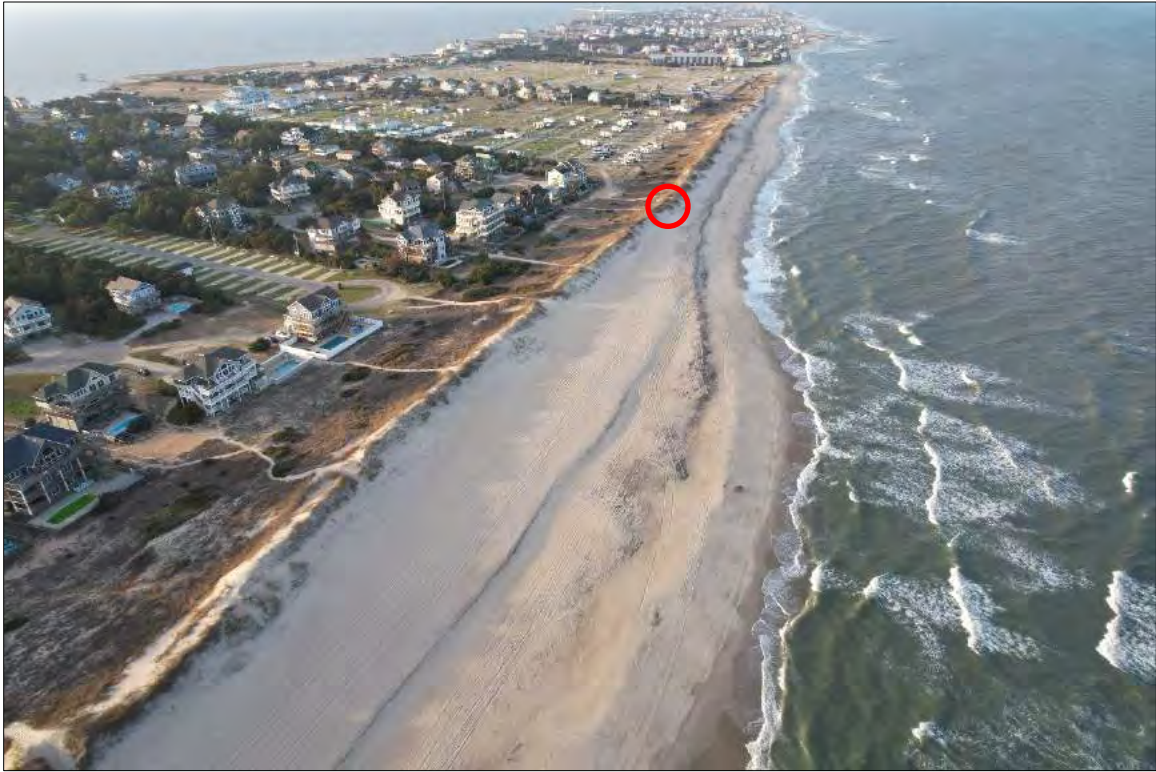
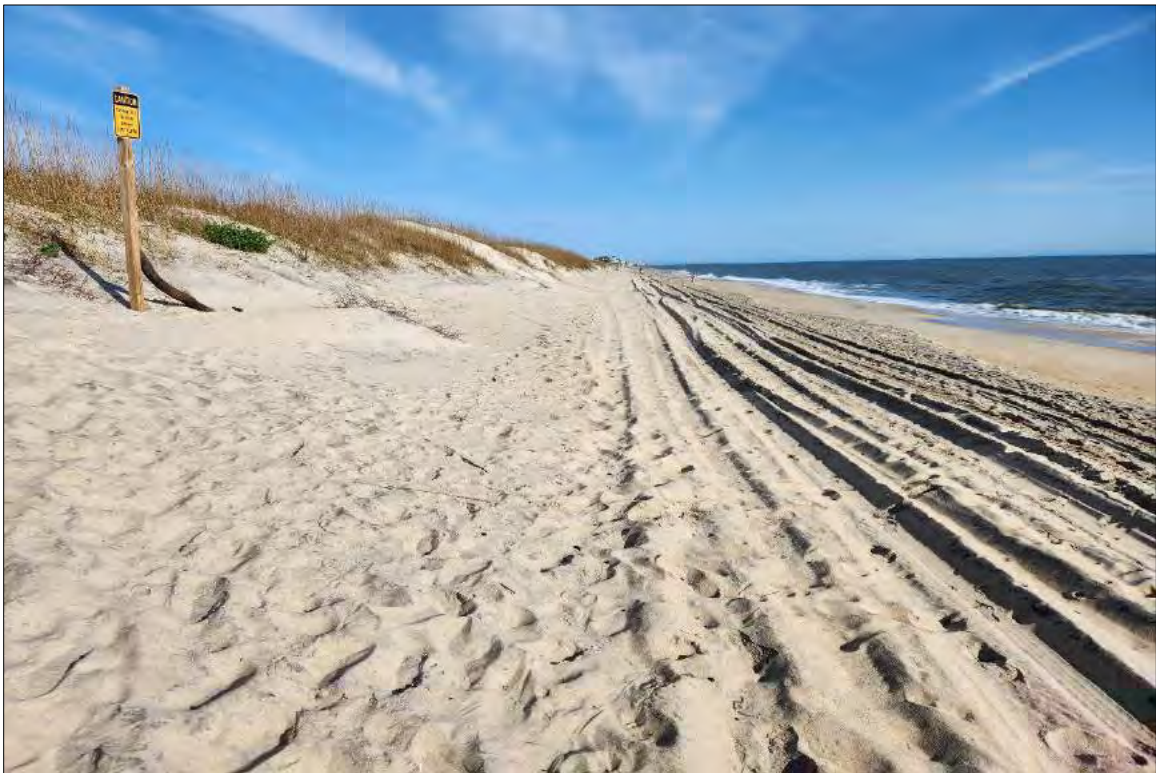
**FIGURE 1.2c.** Beach conditions along the Waves reach offer greater storm protection than Rodanthe, with a dry sand beach and continuous dune crest between the first row of properties and the ocean. The ground photo location is marked in the upper photo with a red circle.

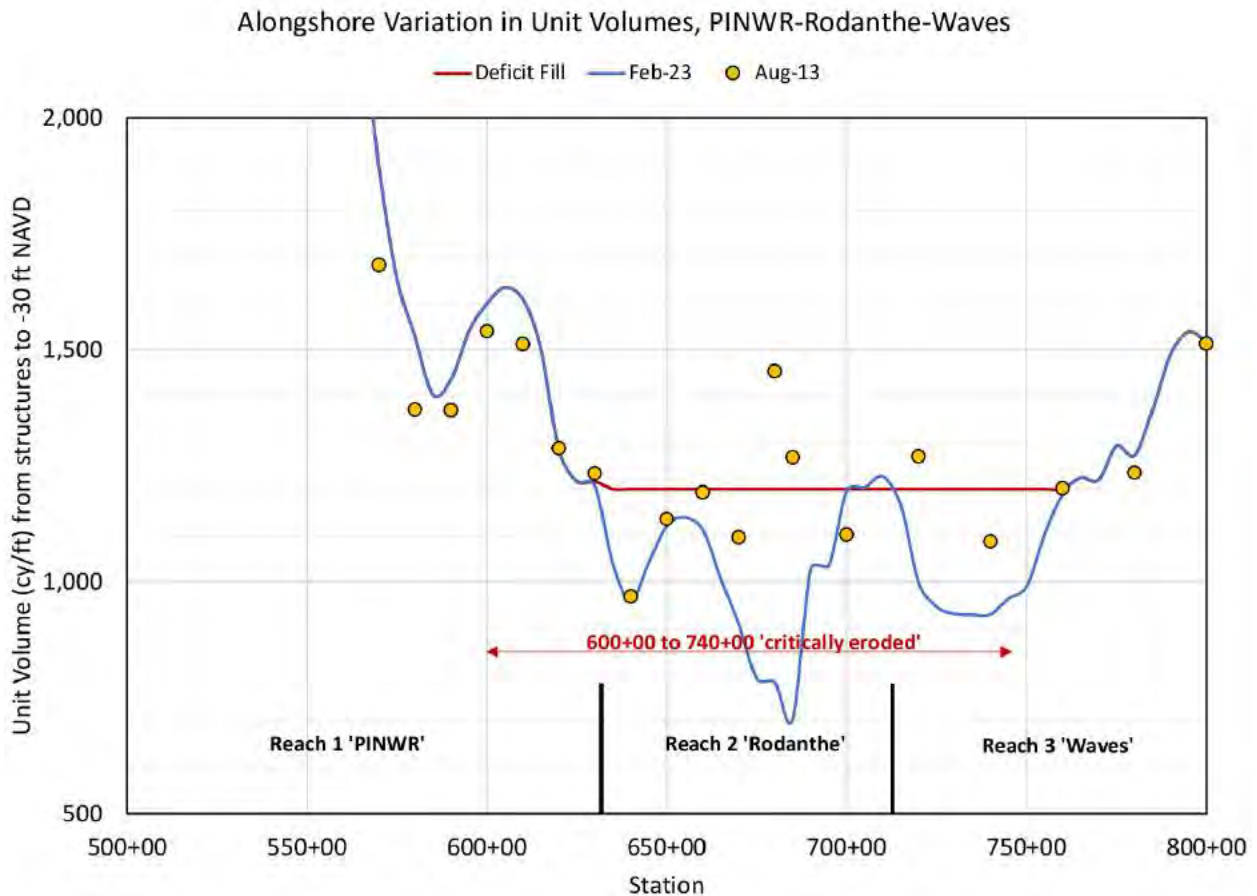
**FIGURE 4.1.** Comparing qualitative beach conditions across the three reaches helps determine what unit volume is necessary for providing a dry sand beach and protective dune. Borrowing from the initial feasibility study published in 2013 by CSE, the present study determined a unit volume of ~1,200 cy/ft from the seaward structure line to DOC provides adequate protection. This condition is met along much of the PINWR and Waves reaches, but is not met along the Rodanthe reach. The ‘critically eroded’ section of shoreline falls below that ideal volume and erodes at >10 ft/yr and lacks a protective foredune, while the line labeled ‘Deficit Fill’ indicates the section of shoreline where unit volumes are below 1200 cy/ft.

The beach between Sta 620+00 and Sta 760+00 falls beneath this ideal unit volume (Figure 4.1). However, Sta 740+00 to Sta 760+00 contain a protective dune. As mentioned in Section 1.0, CSE considers an individual profile to be critically eroded if it lacks a continuous foredune, has an NCDENR-adopted erosion rate exceeding 10 ft/yr, and a unit volume seaward of the structure line below 1200 cy/ft. These criteria are met from Sta 600+00 (~3,500 ft north of the Mirlo Beach sign) to Sta 740+00 (~2,500 ft south of Rodanthe Pier).

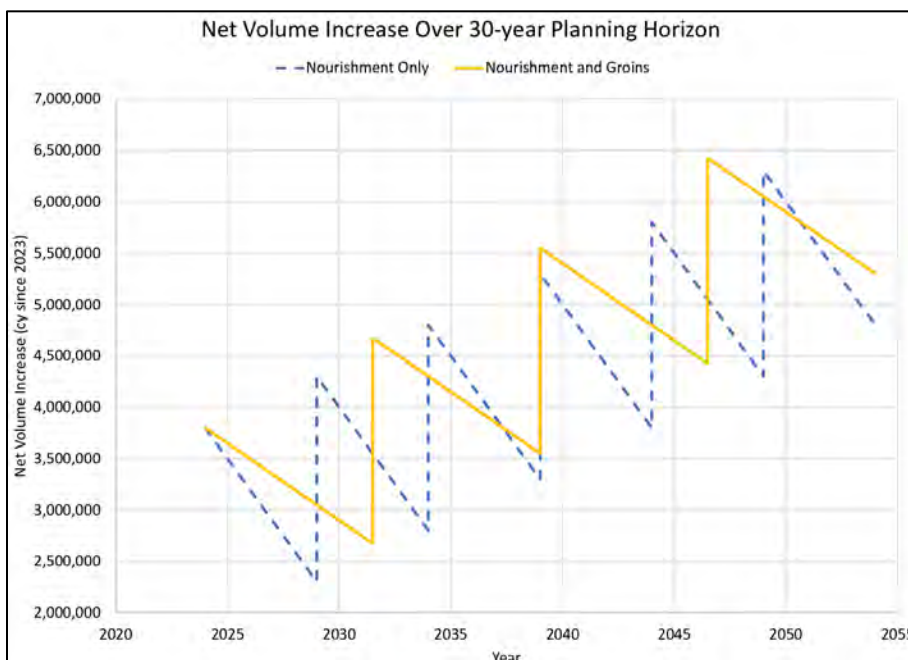
**FIGURE 6.1.** If groins are able to reduce annual erosion rates by 50% along Rodanthe – as has been observed in other project locations managed by CSE – then the interval between projects can reasonably be extended from 5 years to 7.5 years. Over a 30-year planning time frame, this results in fewer projects with more sand placed along the critically eroded area.

Considering the County wishes to maintain a dry sand beach and protective dune along Rodanthe, repeat renourishment projects will be necessary. If 5-year erosion rates average ~1.5 million cy along the critically eroded area, subsequent renourishment events would need to exceed this total and place ~2 million cy per event. Over a 30-year planning horizon, factoring background erosion of ~300,000 cy/yr, such a plan would leave the project area with 4.8 million cy more sand in 2054 than 2023 (dashed line, Figure 6.1).

If the County is able to install groins that can reduce post-project erosion by ~50%, the return interval between projects can be extended from 5 to 7.5 years while still retaining more sand than the no-groin alternative. Assuming the same initial project volume (eg 3.8 million) and installation of a groin field as described in Section 6.0, the County could renourish the critically eroded area with 2 million cy every 7.5 years. Over a 30-year planning period this results in a net volume increase of 5.3 million cy above the 2023 condition (solid line, Figure 6.1).

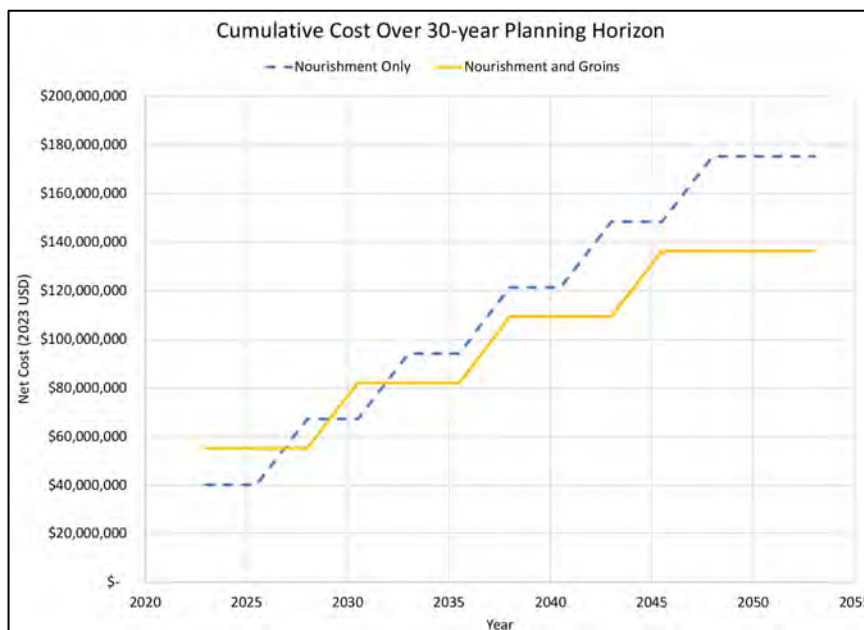
**FIGURE 6.2.** While the initial investment in groin installation and a large-scale beach restoration makes the structural alternative more expensive, those costs are surpassed by the nourishment-alone option by the mid-2030s. These projections assume constant mob/demob costs and unit costs throughout the 30-year planning horizon.
